FIELD TESTS OF THE CUCARACHA FORMATION, PANAMA CANAL, 1942-1946

C. K. Smith, R. J. Lutton

May 1974

Conducted by U. S. Army Engineer Waterways Experiment Station
Soils and Pavements Laboratory
Vicksburg, Mississippi

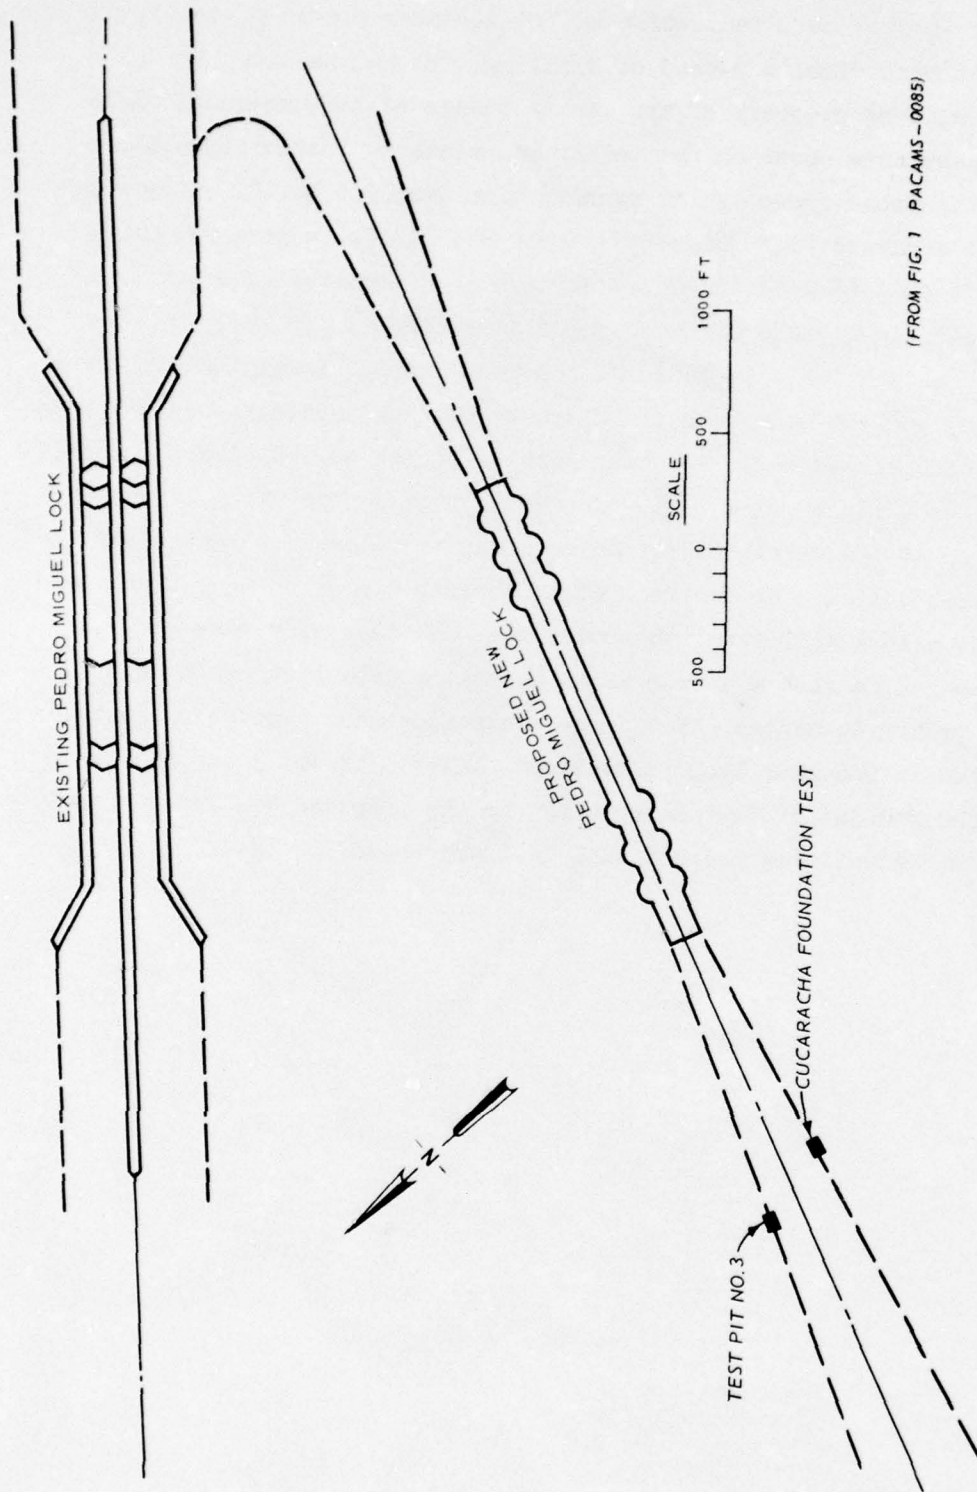
Fig. 1. Location of Test Pit No. 3 and the Cucaracha Foundation Test with respect to the existing and proposed locks

5. Field tests at Pedro Miguel Test Pit No. 3 resulted in lower values of shearing strength and ultimate bearing capacity than had been previously recommended. All test results seemed to indicate the desirability of a large-scale test which would average the variable characteristics of the Cucaracha formation and give values applicable for structural design. It was decided to perform a bearing test that would simulate a lock wall monolith prototype. The test structure would be instrumented in such a manner as to determine data that could be used in the prototype design. The large-scale Cucaracha Foundation Test was initiated in December 1943. Locations of Test Pit No. 3 and the Cucaracha Foundation Test in relation to the proposed New Pedro Miguel Lock and the existing Pedro Miguel Lock are shown in fig. 1

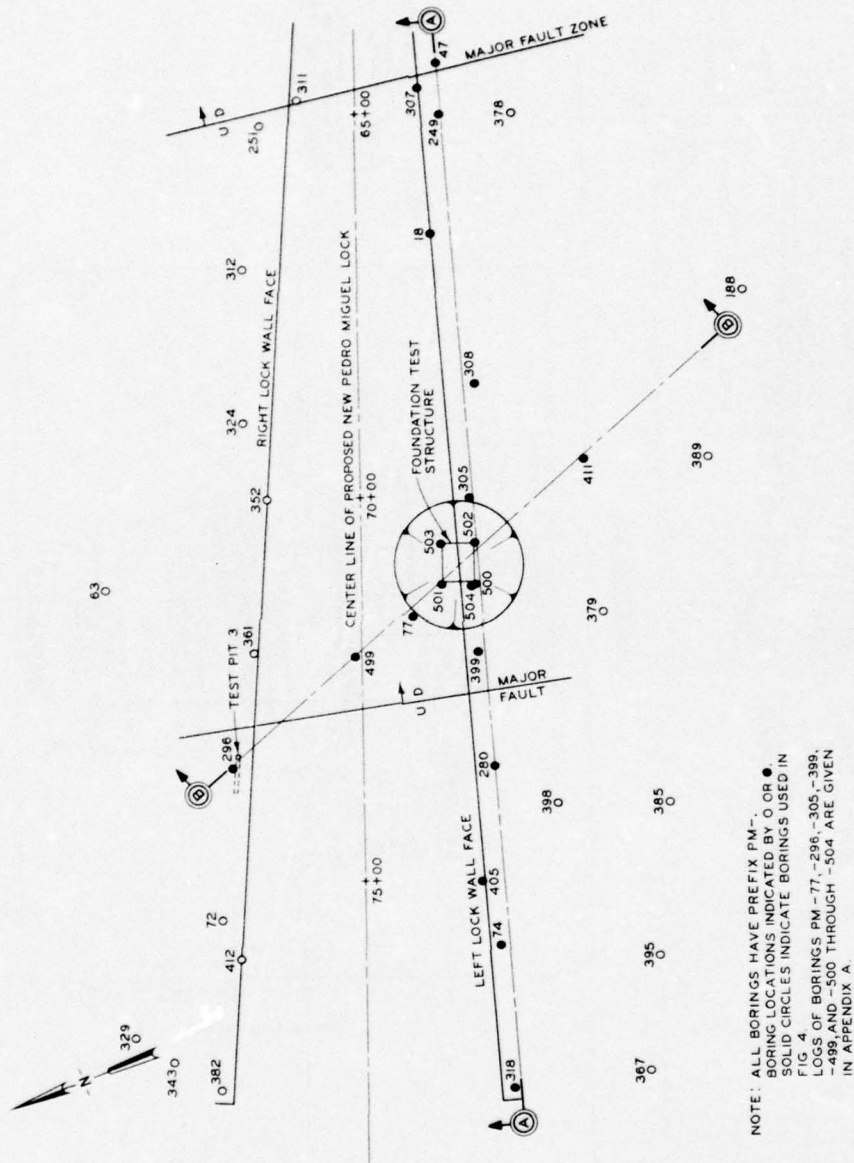
Fig. 3. Locations of test sites, major faults, borings through 1946, and geologic sections

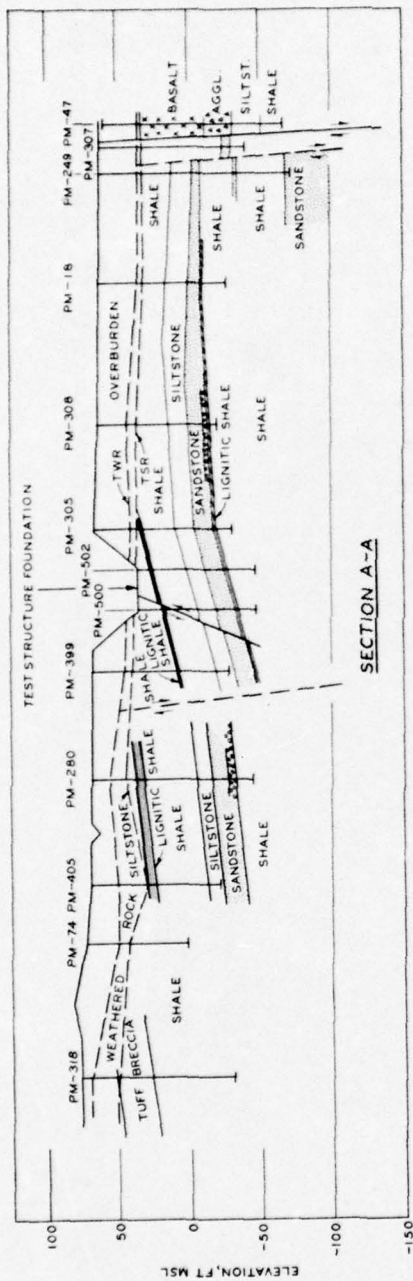
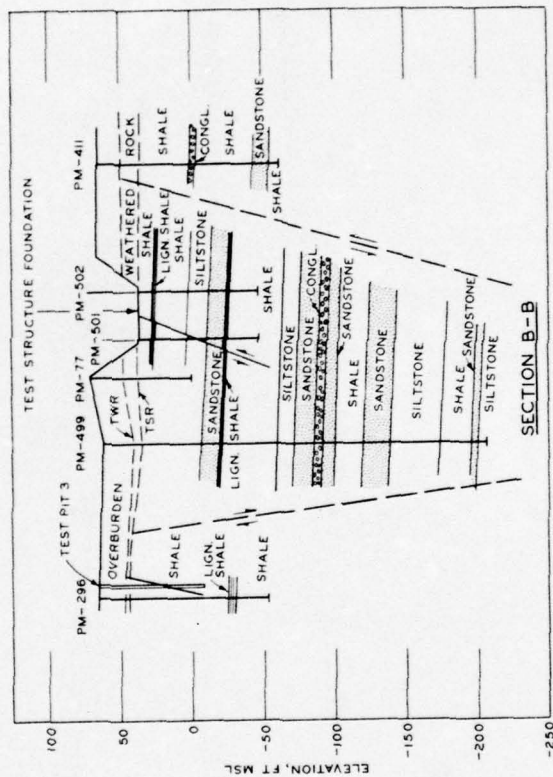
NOTE: SEE FIG. 3 FOR LOCATIONS
VERTICAL HORIZONTAL SCALE
EXAGGERATION IS 2:1 AS IN
FIG. 2.
SECTION A-A IS PREFERRED
OVER EARLIER INTERPRETATIONS
ALONG SAME LINE IN FIG. 2

Fig. 4. Geological sections of test sites.

8. Test Pit No. 3 (excavated in 1942) and the foundation test in 1944 were located on the lines of the right and left lock walls, respectively. Five borings were made near corners of the foundation test base to establish geological details immediately below. The locations of exploratory borings for the lock walls and test excavations and of the additional borings at the foundation test base are shown in fig. 3. Revised geological cross sections through the two test sites are given in fig. 4.

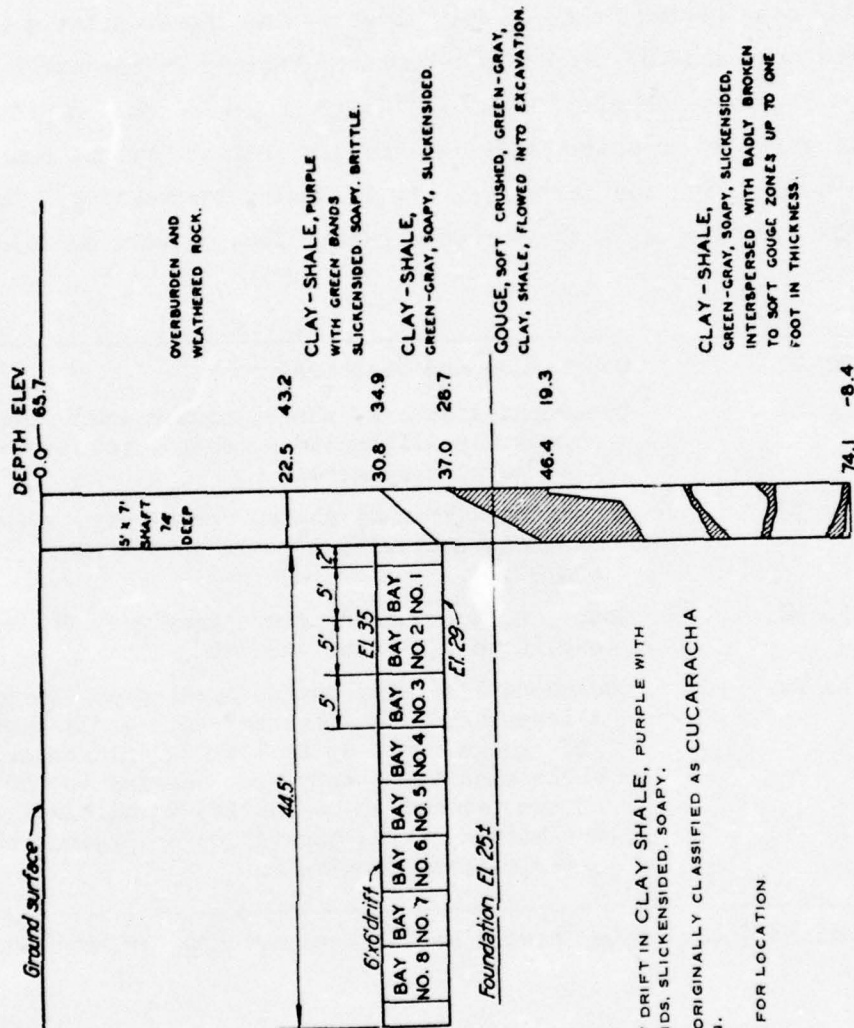
PM - TP-3
STA 73+35 (P-8-C AXIS)
161' R.

BOTTOM OF DRIFT IN CLAY SHALE, PURPLE WITH GREEN BANDS. SLICKENSIDED. SOAPY.
ALL ROCK ORIGINALLY CLASSIFIED AS CUCARACHA FORMATION.

21. A drift (fig. 5) was excavated between depths of 30 and 36 ft in the north wall of the shaft. The drift was 6 by 6 ft and extended 45 ft back into the shale. This location was selected to allow testing of the very slickensided purple shale at about the foundation level of the proposed lock. As can be seen from the section in fig. 5, the material tested appears in the shaft between depths of 22 and 31 ft and

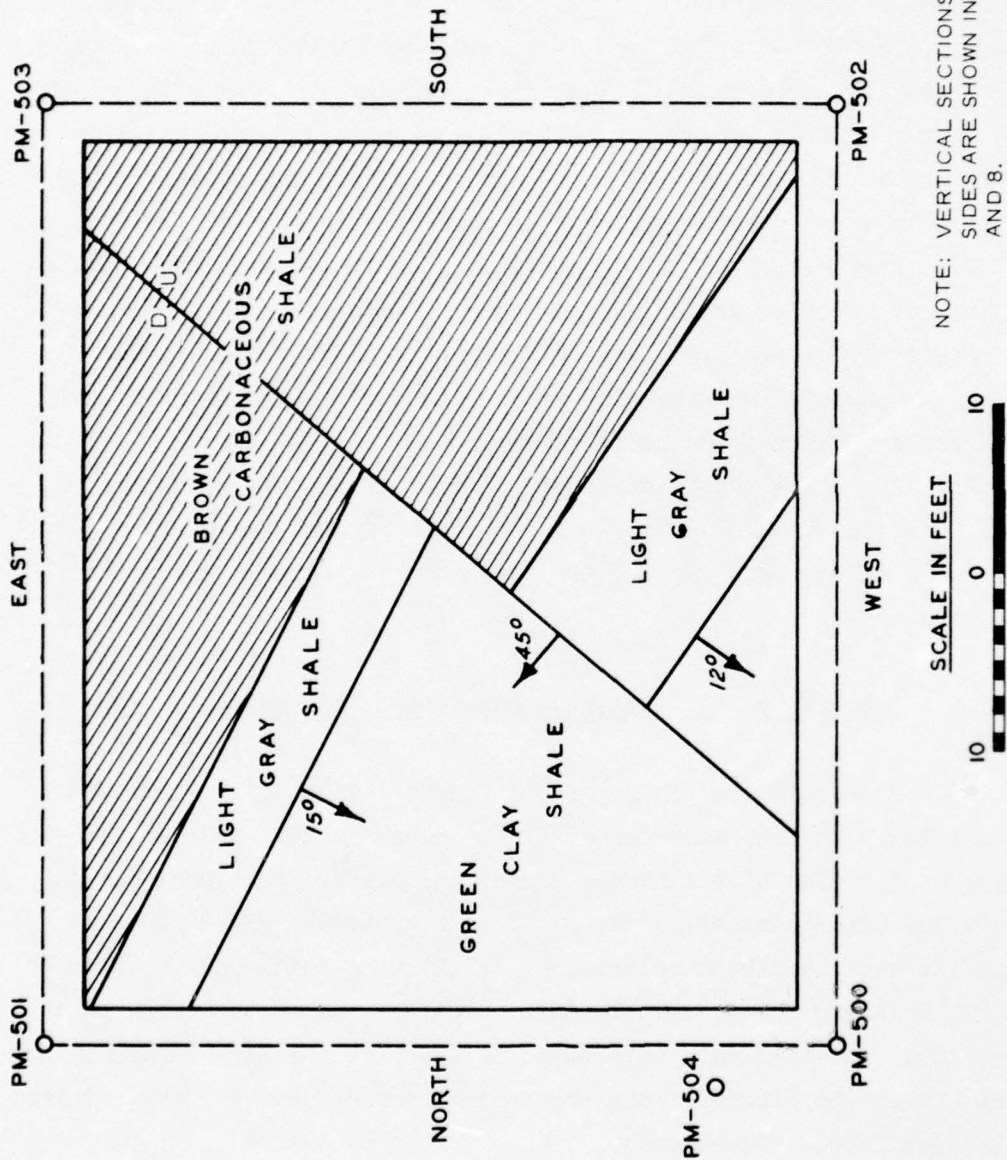
Fig. 6. Geologic plan of test structure base

30. A carbonaceous shale exposed on the test base (fig. 6) was the weakest member, and its presence was believed by Thompson³ to be the prime factor in the settlement observed (see Part V). Beds of this character occur as lenses scattered throughout the Cucaracha formation along the Panama Canal, but aggregate only about 6 percent of its total thickness and are generally less than 6 ft thick. Stresses created by regional folding have been relieved by slippage along bedding laminae with resultant mashing. This slippage is locally reflected by small seams or lenses of soft, brown carbonaceous clay found at various locations within the beds but without large lateral extent. These interbedded gouge seams are soft and plastic, and because of their considerable organic content absorb much water after release of confining pressure.

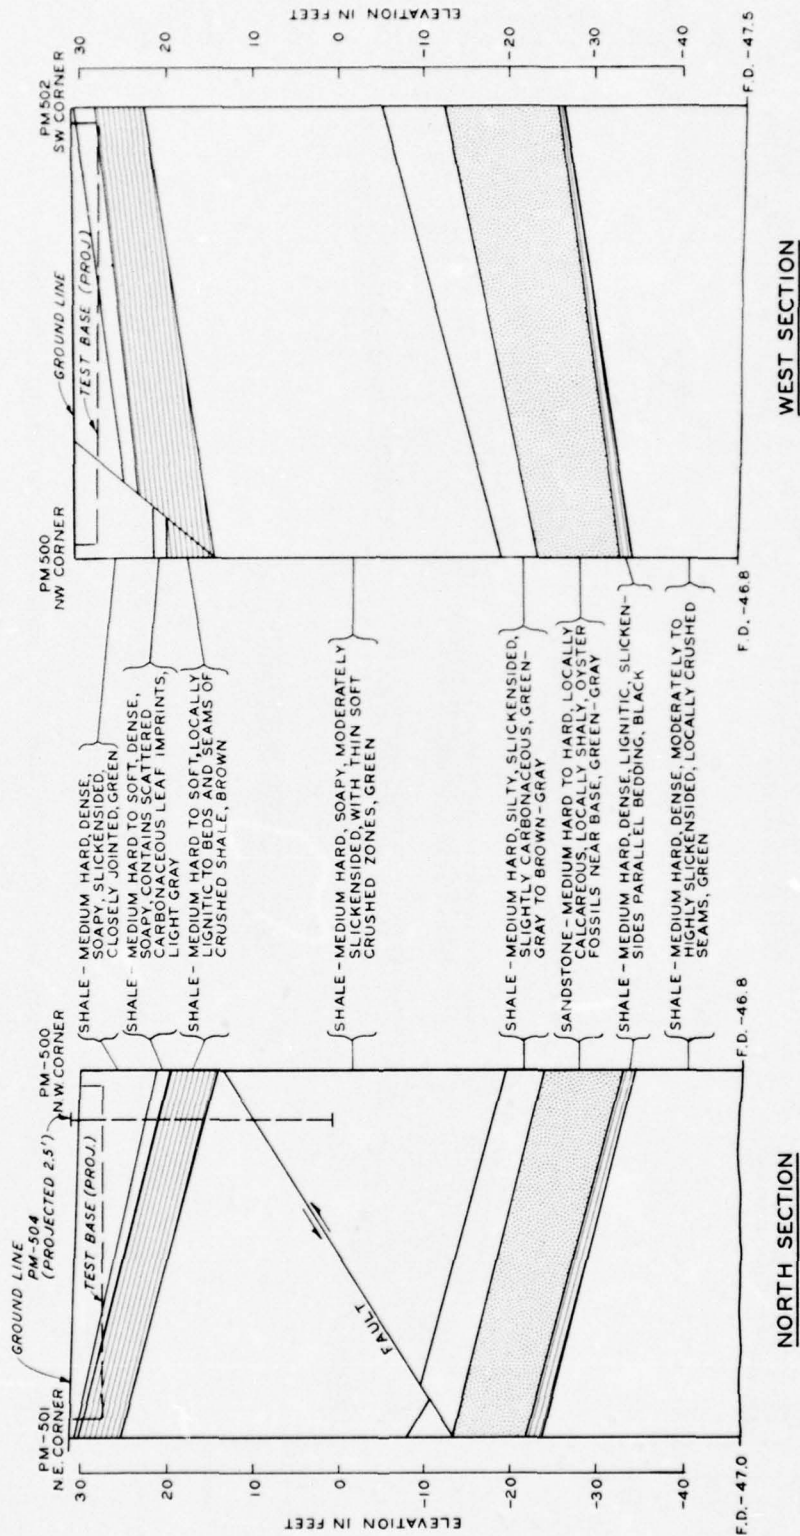
Fig. 7. Geologic sections of north and west sides of test structure base

32. Green shale, three beds of which were encountered (figs. 7 and 8), was similar to typical shale of the Cucaracha. Strength of the green shale varies depending on slickenside spacing and degree of

33. The green-gray sandstone bed shown on figs. 7 and 8 has a maximum thickness of about 12-1/2 ft. The rock is variably calcareous and argillaceous and accordingly has a considerable range in strength. Its subsurface trend along the right wall of the proposed New Pedro Miguel Lock (fig. 6) can be traced 650 ft southeast, and it thins considerably in that direction. This bed is the strongest revealed in foundation test borings and is comparable in strength to similar units occurring in the lower third of the Cucaracha formation and the upper portion of the Culebra. Thickness variations beneath the test site reflected the presence or absence of shaly interbeds. A layer rich in oyster shells was used as a reference in determining the subsurface structure.

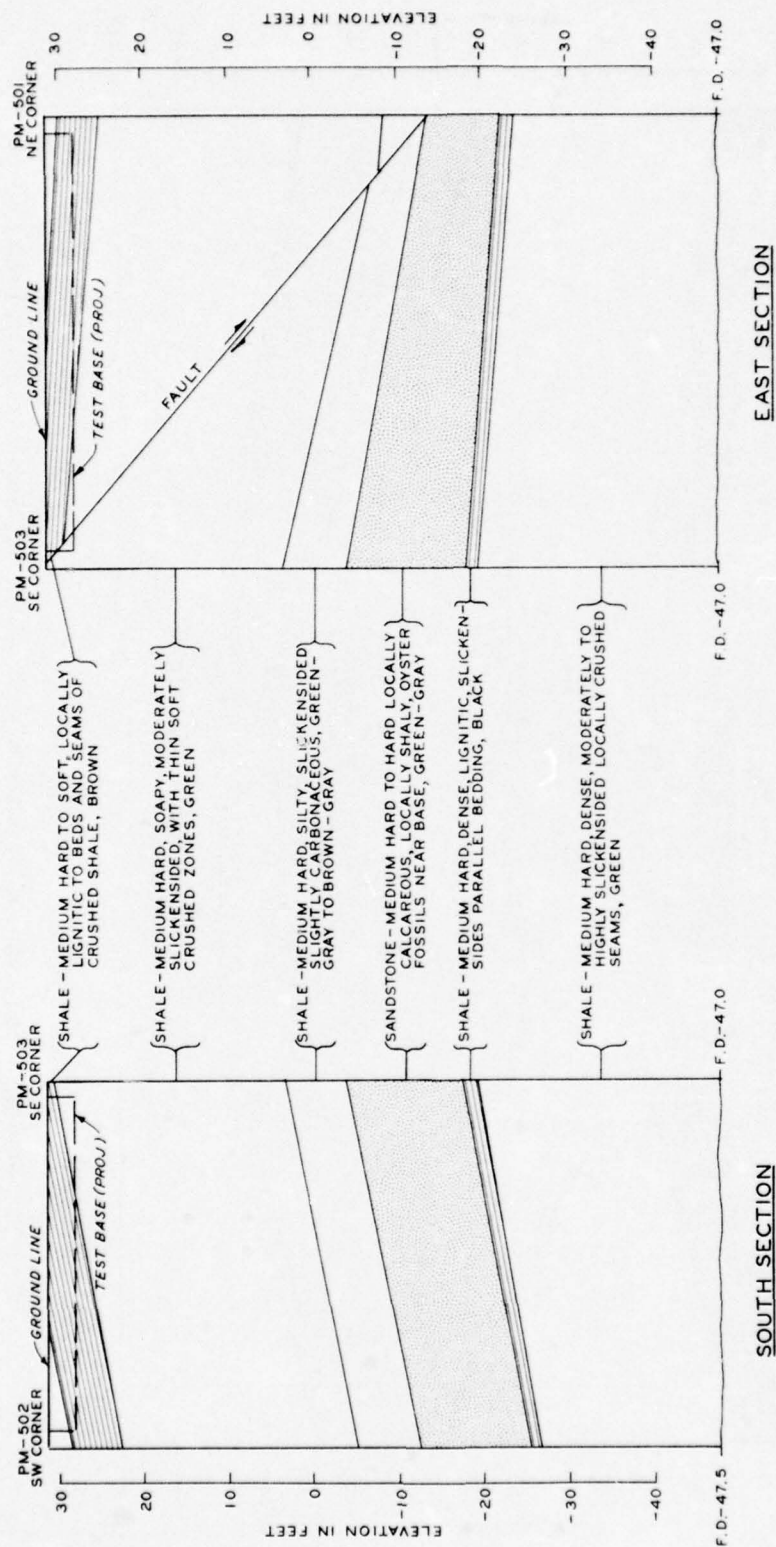
Fig. 8. Geologic sections of south and east sides of test structure base

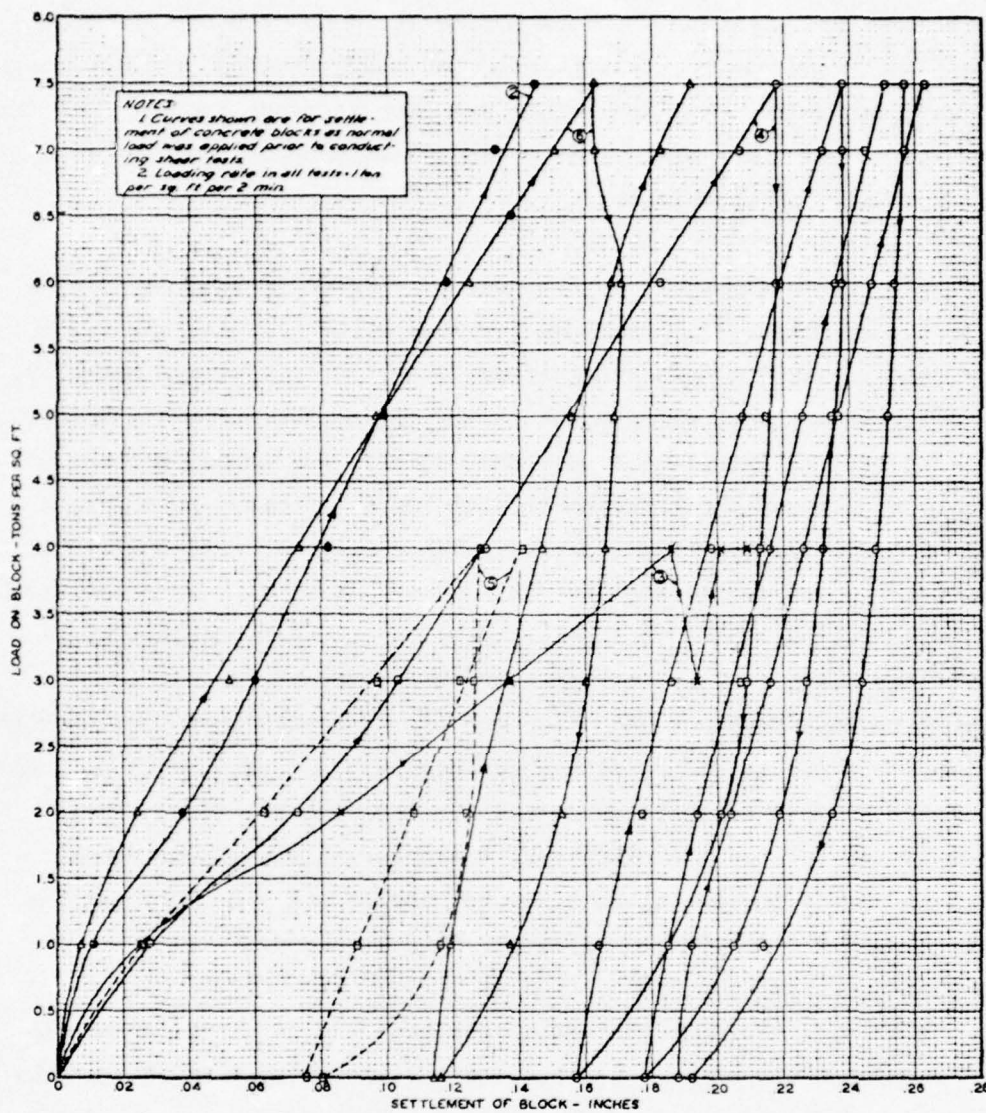
Fig. 9. Load versus settlement of concrete blocks prior to conducting field shear tests, Pedro Miguel Test Pit No. 3

settlement tests are shown in fig. 9 and table 1.

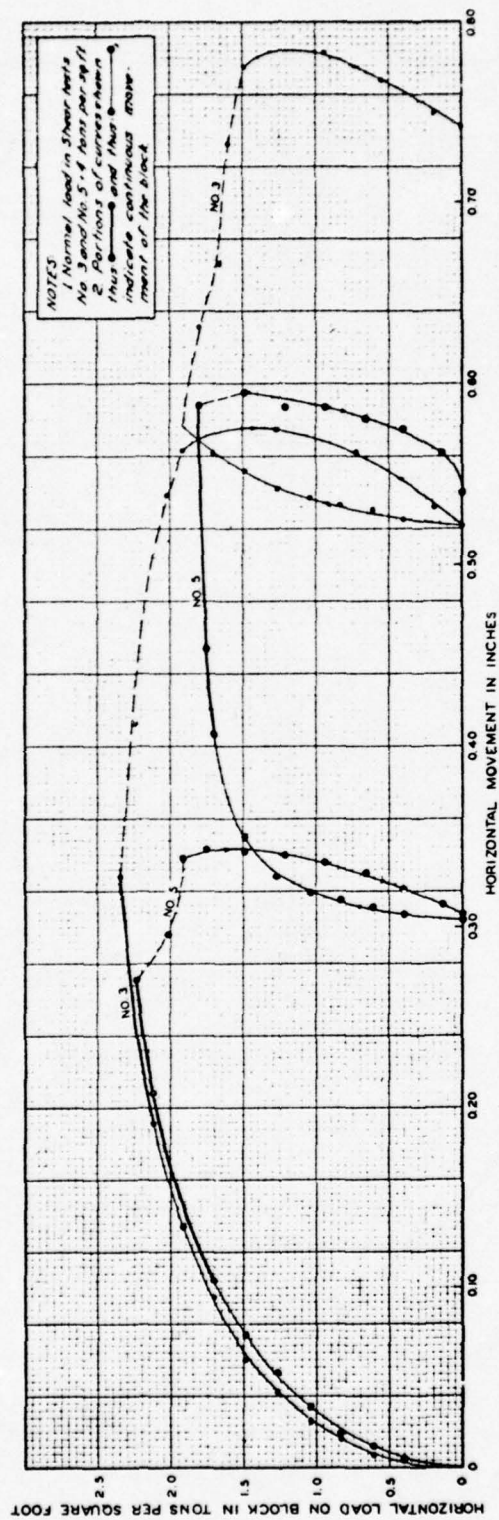
Fig. 10. Load versus movement, field shear tests 3 and 5,
 Pedro Miguel Test Pit No. 3

47. Six shear tests were conducted on grooved surfaces of the shale in the field. Two of these tests were run at 4 tsf and the other four were run at 7.5-tsf normal stress load. In all of the tests, failure occurred in the Cucaracha but at varying depths below the bottom of the grooves. Failure, which was attained very gradually, was considered to be the point at which the horizontal force necessary to maintain continuous movement of the block began to decrease. This shear stress defined what was termed the "ultimate shear strength." When the block had moved out for some distance after failure, the pressure was released and again applied in increments until the block once more started to move continuously while the pressure was maintained constant. The point on the second cycle beyond which the pressure could no longer be increased defined what was termed the "sliding friction value." Figs. 10 and 11 show the results of the observations of horizontal movement versus horizontal load for the tests, and Fig. 12 shows the ultimate shear strength and sliding friction values.

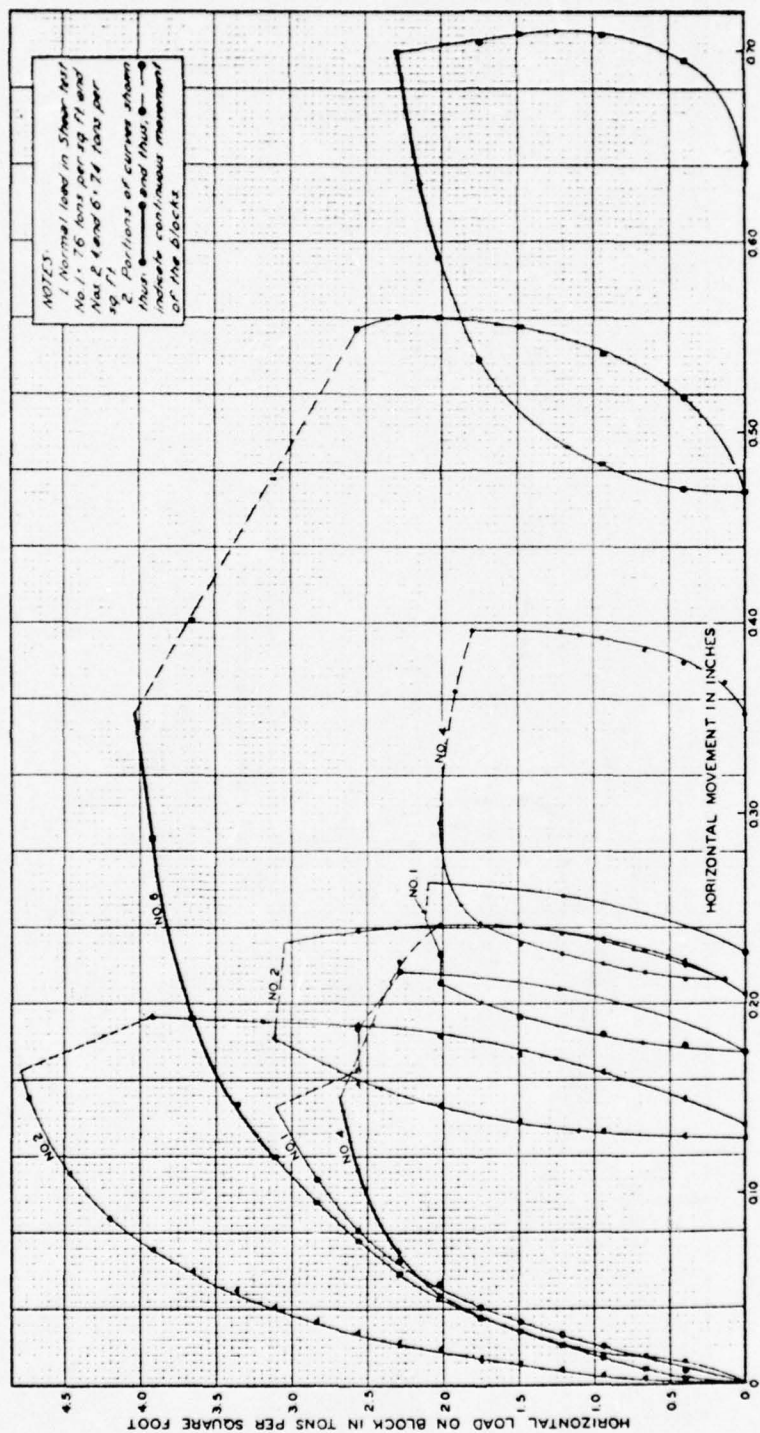
Fig. 11. Load versus movement, field shear tests 1, 2, 4, and 6,
 Pedro Miguel Test Pit No. 3

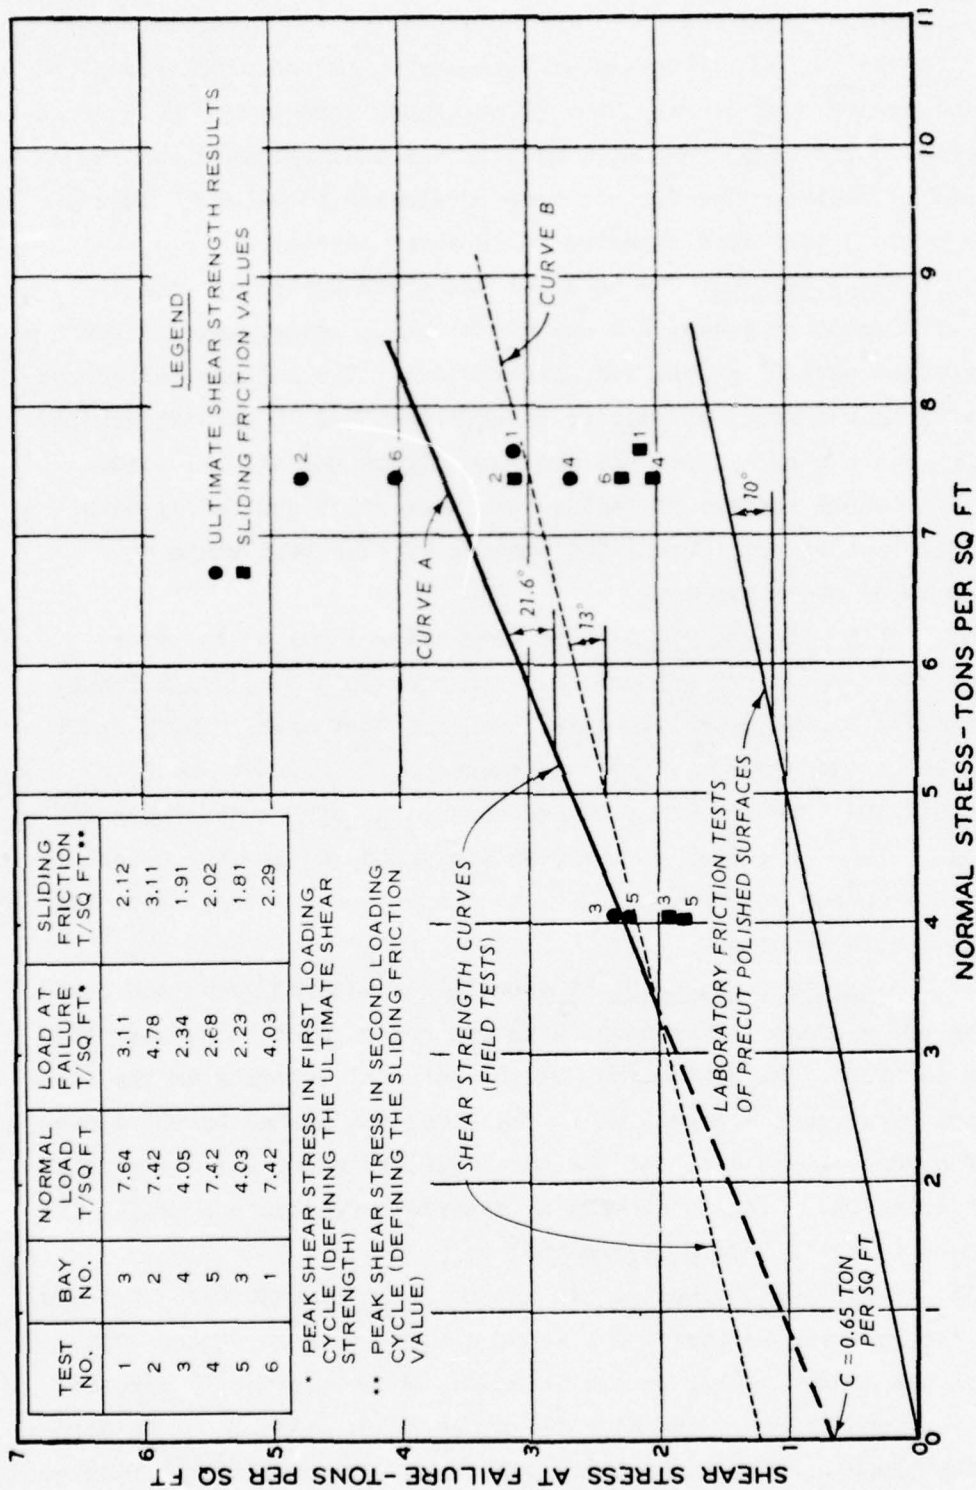
Fig. 12. Shear strength curves for field tests and laboratory friction tests, Pedro Miguel Test Pit No. 3

48. Fig. 12 shows that good agreement was obtained between the two tests at 4-tsf normal load but the ultimate strengths of the four tests at 7.5-tsf normal load varied over a large range. An analysis of the variations in the material and of the irregularities in the type of failure produced in each test was made in an effort to determine which, if any, of the tests could be omitted as not representative. A summary of the factors considered is presented in the following paragraphs.

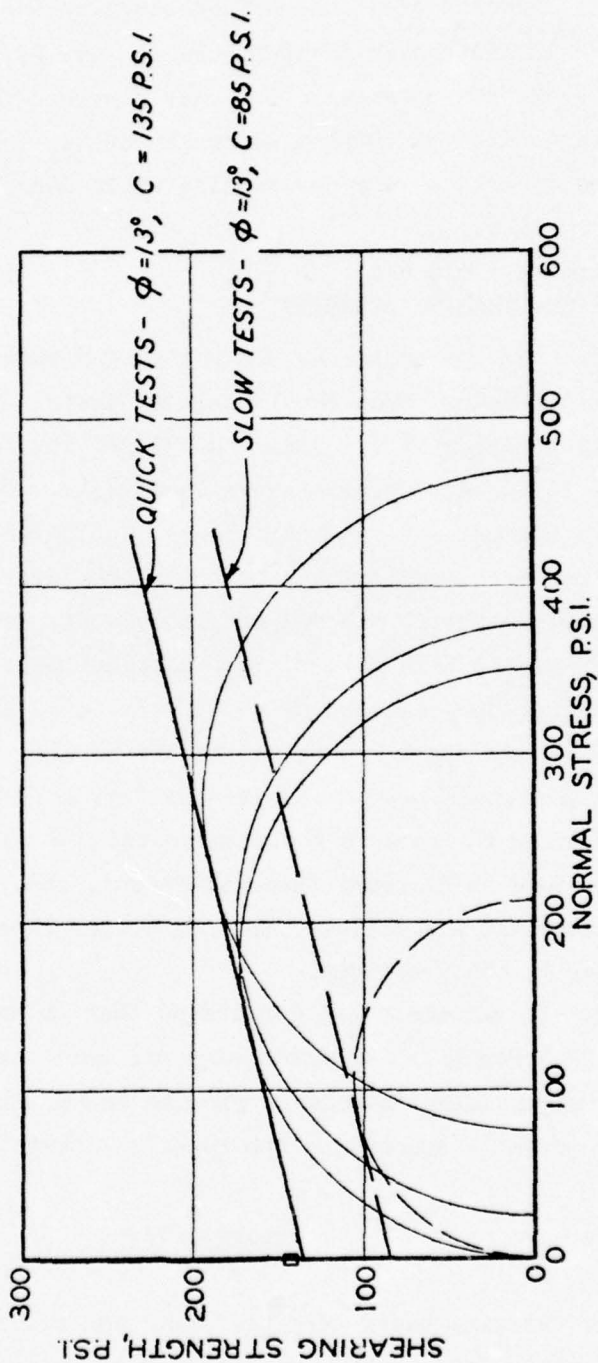
LATERAL STRESS P. S.I.	LOADING RATE	ULTIMATE STRENGTH				NO. TESTS
		MAX P.S.I.	MIN. P.S.I.	MEAN P.S.I.	AVE. P.S.I.	
0	SLOW	463	69	210	214	20
0	QUICK	550	138	338	349	14
25	"	623	147	310	374	9
75	"	609	317	449	468	9
SINGLE SHEAR	"	215	78	151	144	5

NOTES:
 FULL DEFORMATION UNDER EACH INCREMENT
 OF LOAD IN SLOW TESTS
 AVERAGE STRENGTHS USED IN MOHR'S CIRCLE
 PLOTS. $\phi = 13^\circ$ ASSUMED FOR SLOW TESTS
 AVERAGE OF SINGLE SHEAR TESTS SHOWN THUS D

61. Results of 34 unconfined compression tests (14 quick and 20 slow) are summarized in tabular form in fig. 13, and average values are plotted as Mohr's circles in the same figure. Test data included in the averages are for samples generally better than the average clay shale and do not include any results which were known to be influenced by slickensides.

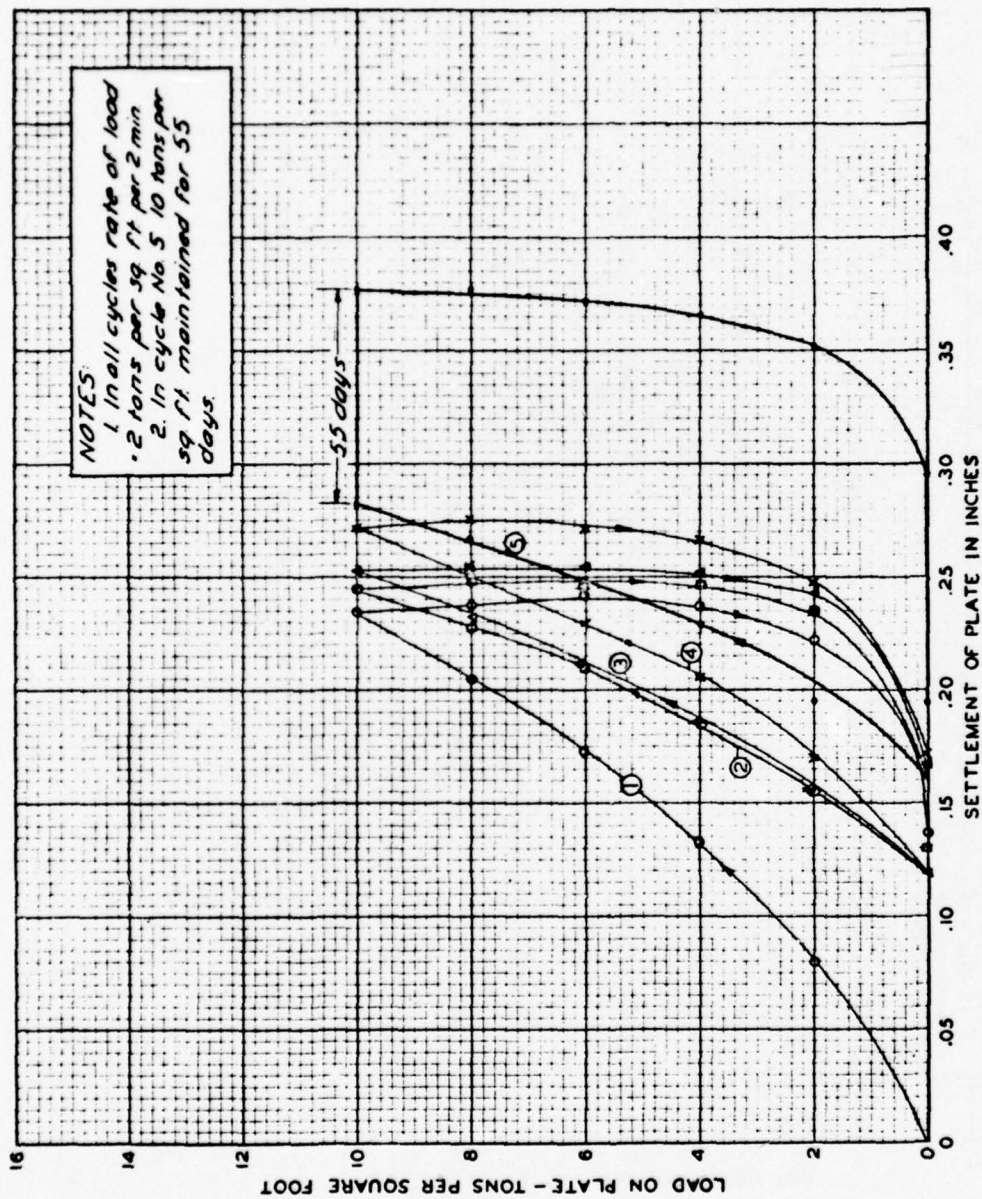
Fig. 14. Load versus settlement, 40-in.-diam plate bearing test,
 Pedro Miguel Test Pit No. 3

71. A total of five bearing tests on circular plates were performed in the field. Tables 2 and 3 are summaries of the results of these tests. Figs. 14-21 show the load versus settlement curves, and figs. 22-27 show the time versus settlement curves.

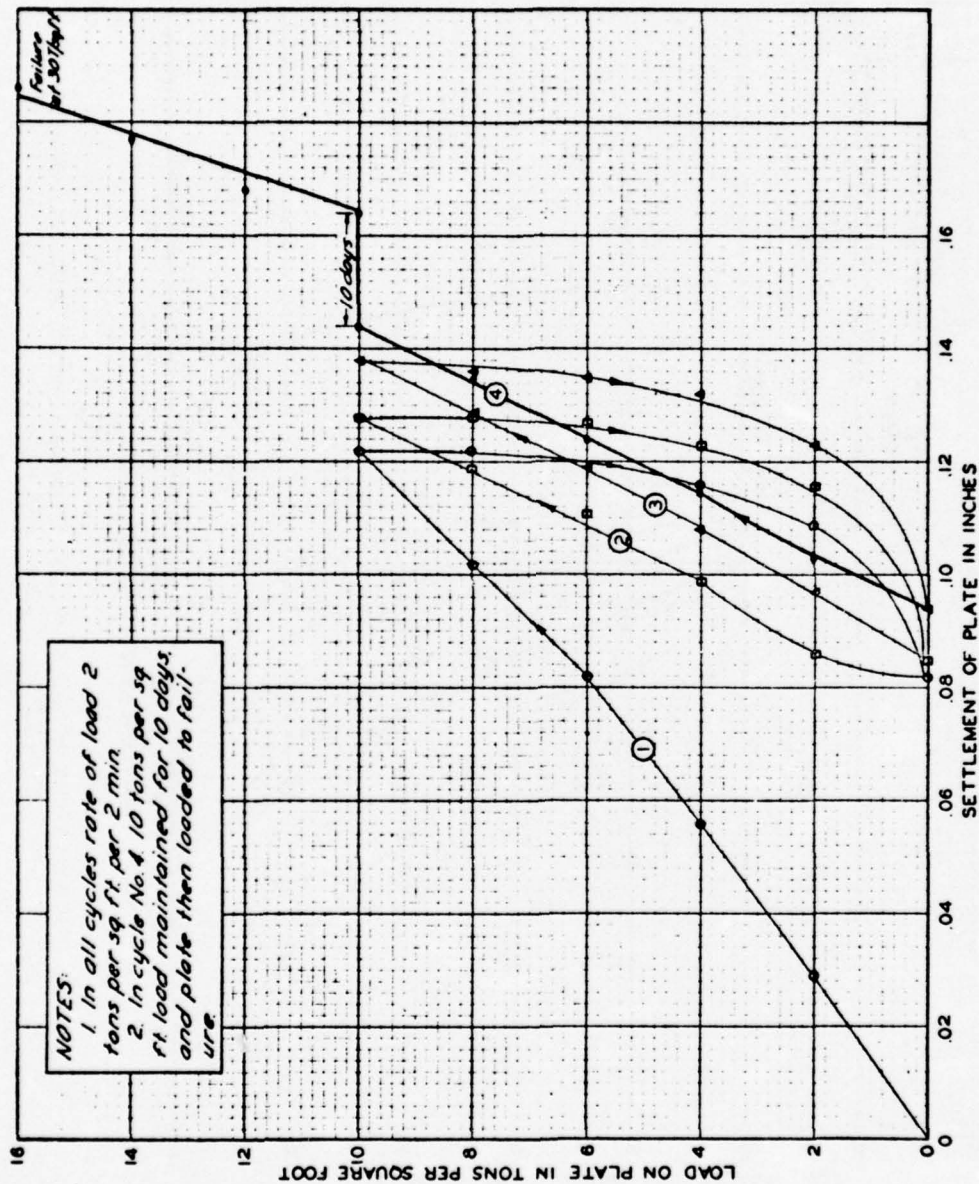
Fig. 15. Load versus settlement, 16-in.-diam plate bearing test, Pedro Miguel Test Pit No. 3

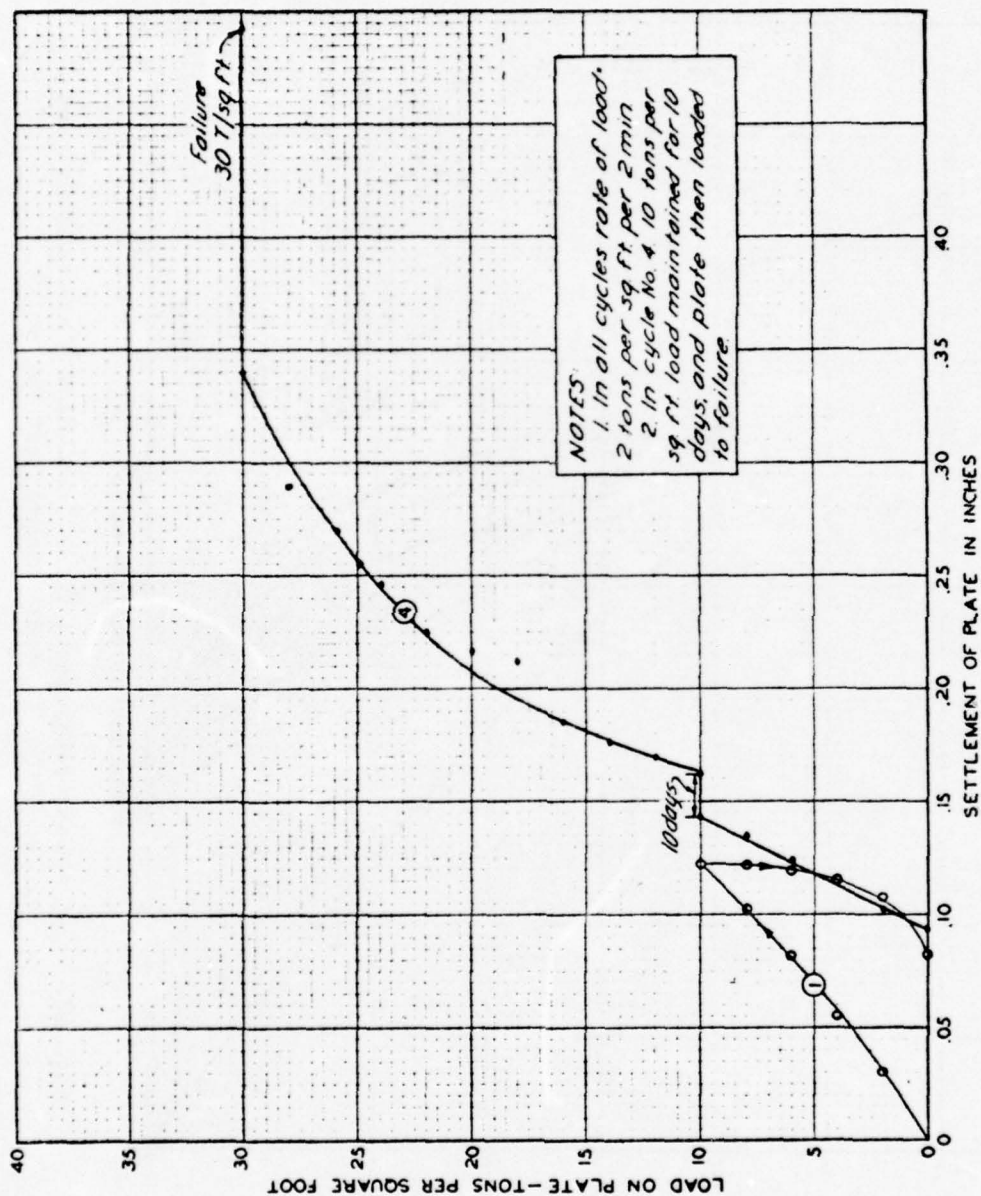
Fig. 16. Load versus settlement, 16-in.-diam plate bearing test, Pedro Miguel Test Pit No. 3

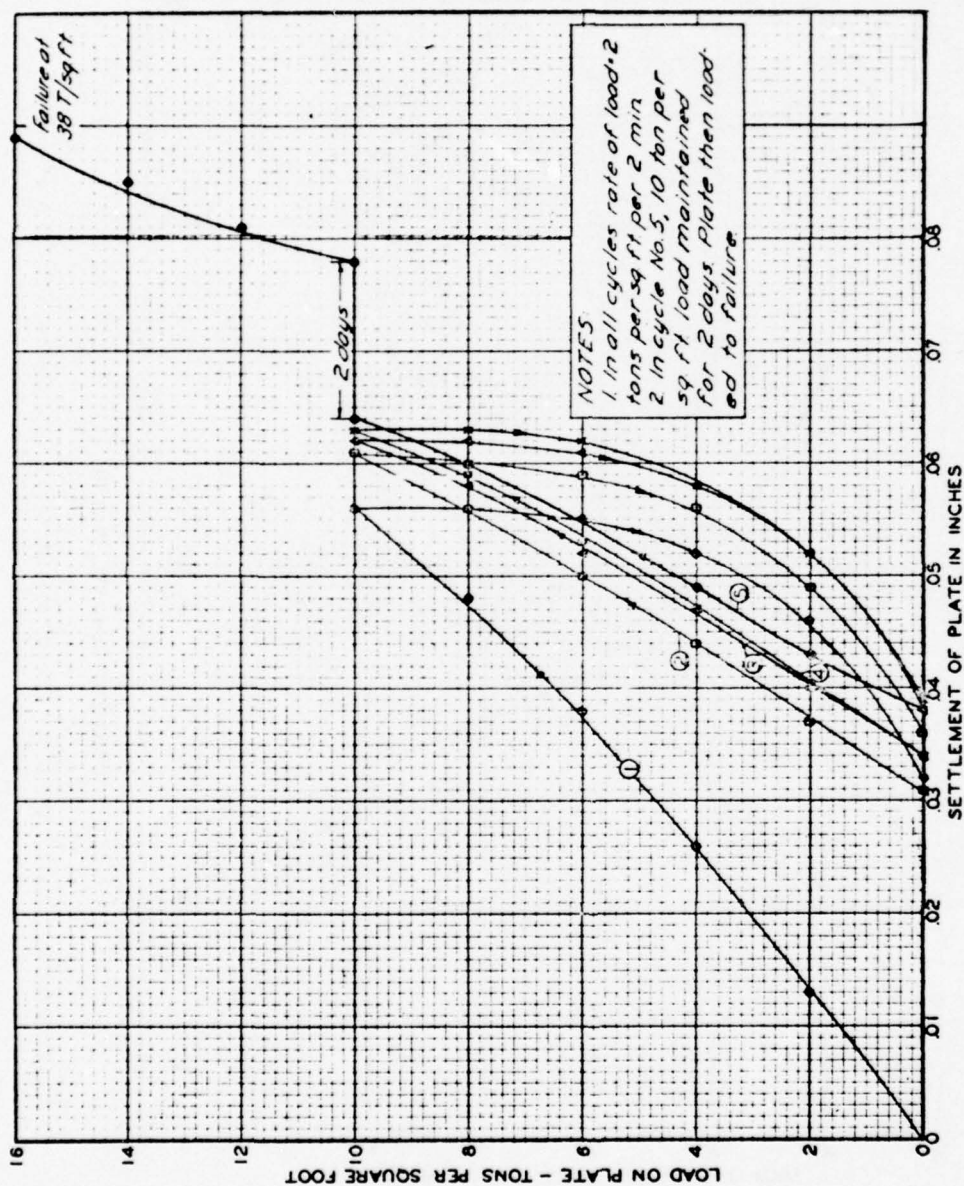
Fig. 17. Load versus settlement, first 8-in.-diam plate bearing test (cycles 1 and 5), Pedro Miguel Test Pit No. 3

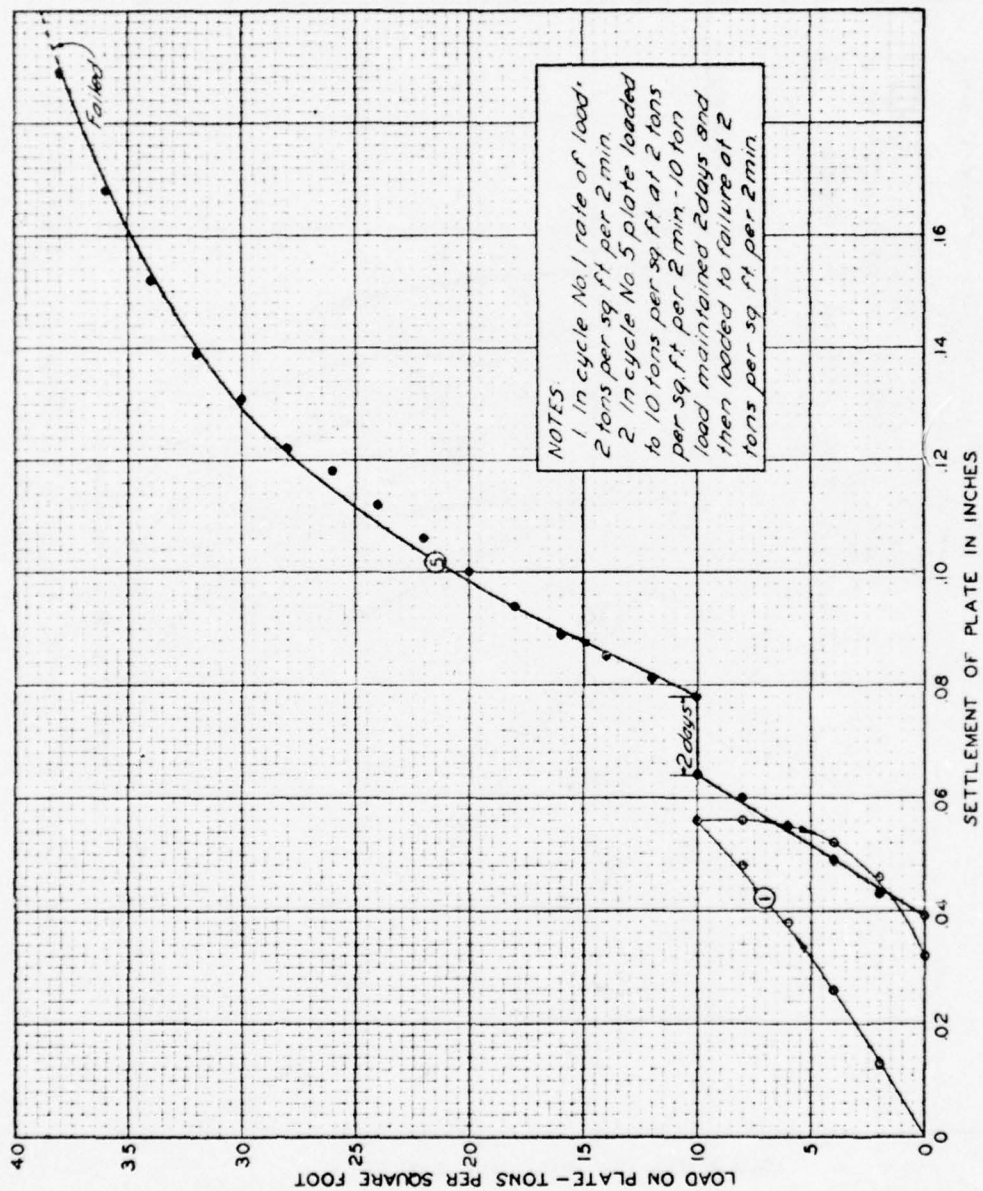
Fig. 18. Load versus settlement, first 8-in.-diam plate bearing test (cycles 1 and 5), Pedro Miguel Test Pit No. 3

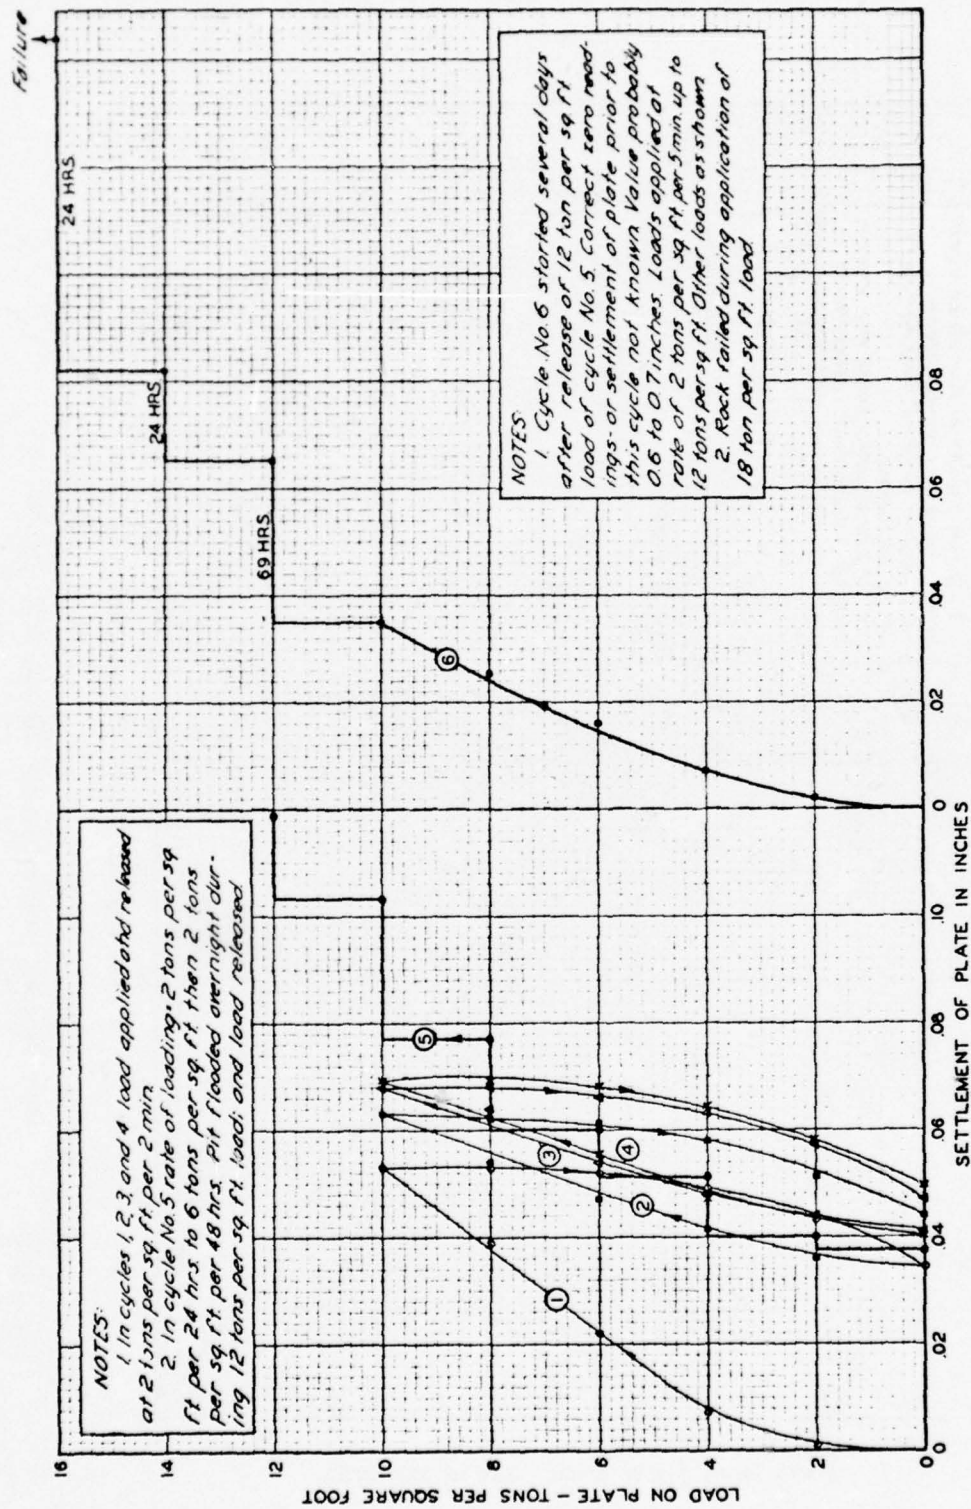
Fig. 20. Load versus settlement, third 8-in.-diam plate bearing test, Pedro Miguel Test Pit No. 3
